IDENTIFICATION OF POST FIRE DAMAGE IN DHARMA BHAKTI MONASTERY BUILDING

James Rilatupa, Naniek Widayati, Rudy Surya, Franky Liauw, Joko Priyono

ABSTRACT

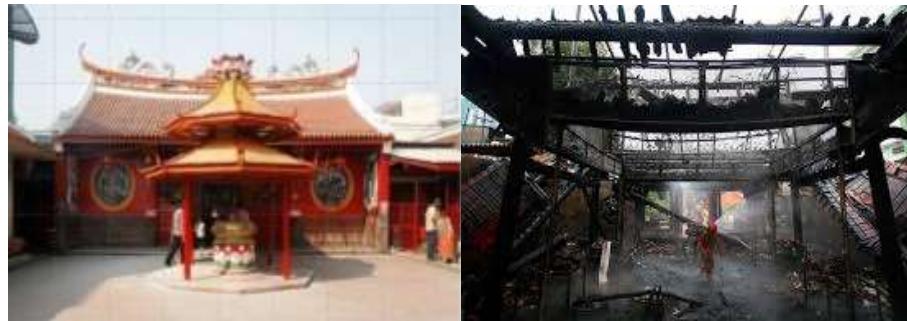
On March 2, 2015 at 03.00 (Jakarta time) in the morning, Dharma Bhakti Monastery experienced a fire. The source of the cause is thought to come from candles and incense inside the Dharma Bhakti Monastery, then spread to the people's house. According to the Monastery's Management, there was one 1.5 meter high candle that fell, while the distance between the flame and the ceiling was close enough; because in 2014 the floor of the room was raised to avoid flooding. Fortunately, there were no fatalities in the incident even though the material loss was estimated at billions of rupiah. The main building of the temple was burned down (Figure 1).

Figure 1 Condition of Dharma Bhakti Monastery: (a) before and (b) after burning.
(source: Management of Dharma Bhakti Monastery)
