IJCIET_09_08_176

IDENTIFICATION OF POST FIRE DAMAGE IN DHARMA BHAKTI MONASTERY BUILDING

James Rilatupa, Naniek Widayati, Rudy Surya, Franky Liauw, Joko Priyono

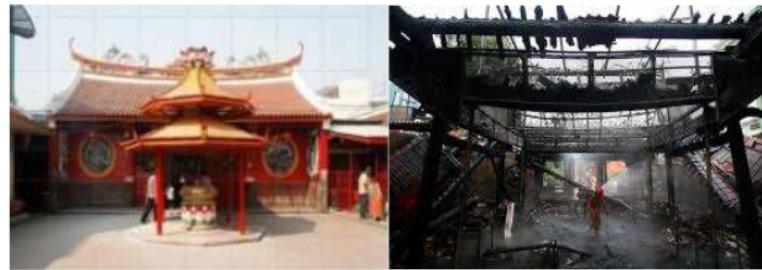
On March 2, 2015 at 03.00 (Jakarta time) in the morning, Dharma Bhakti Monastery experienced a fire. The source of the cause is thought to come from candles and incense inside the Dharma Bhakti Monastery, then spread to the people's house. According to the Monastery's Management, there was one 1.5 meter high candle that fell, while the distance between the flame and the ceiling was close enough; because in 2014 the floor of the room was raised to avoid flooding. Fortunately, there were no fatalities in the incident even though the material loss was estimated at billions of rupiah. The main building of the temple was burned down (Figure 1).

Figure 1 Condition of Dharma Bhakti Monastery: (a) before and (b) after burning.
(source: Management of Dharma Bhakti Monastery)
