Lesson Learnt from Road Accident Investigation in Indonesia

Prof. Ir. Leksmono Suryo Putranto, MT, Ph.D
Professor in Road Traffic Safety, Tarumanagara University
Head of Road Transport Accident Investigation
National Transport Safety Committee

International Seminar on Sustainable Transportation and Safety Measures
Smart Driving Research Center-Universiti Tun Hussein On Malaysia
Batu Pahat, 16 April 2017

**CRASH BETWEEN TRAIN 1528 FROM JATINEGARA TO BOGOR
AND MEDIUM BUS B-7760-FD FROM KAMPUNG BANDAN TO
KALIDERES AT RAIL CROSSING 05 KM 03+739 TUBAGUS
ANGKE ROAD, TAMBORA DISTRICT, WEST JAKARTA,
SUNDAY, 6 DECEMBER 2015, 08.43 A.M.**

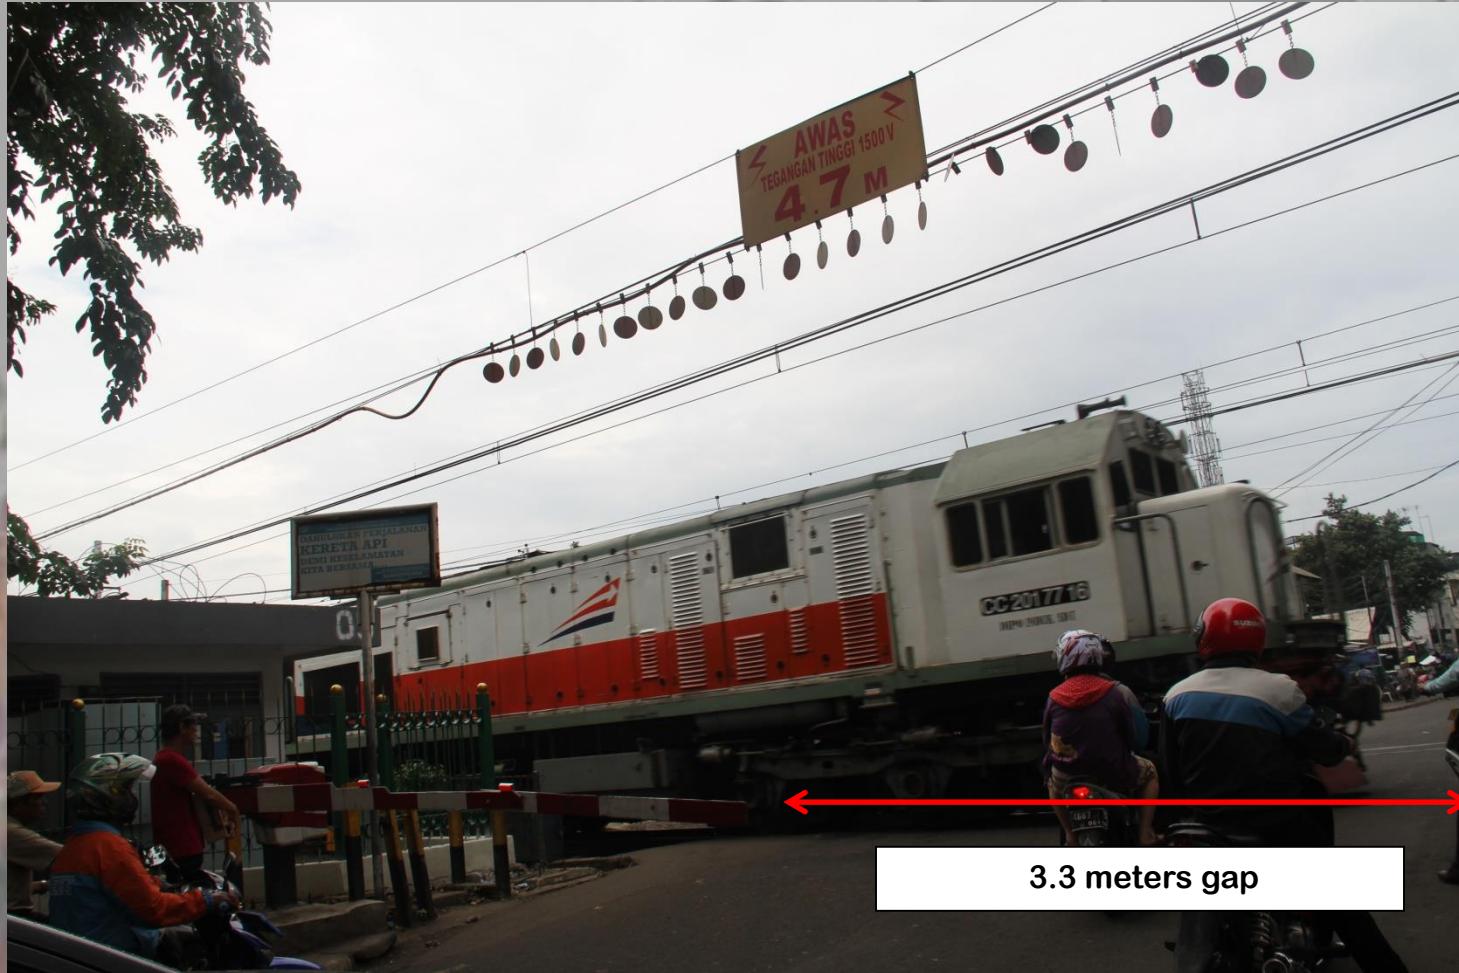
There was 3.3.meters gap (uncovered) during the rail corssing closure that can be used by the medium bus to violate the closure

The doorstop length was only 4.2meters whilst the road with was 7.5meters, leaving 3.3meters gap. This allowed the minibus to enter the crossing. According to Minister of Transportation Regulation No. 10 Year 2011 point no. 5.1., doorstop shoul fully covered the road with to avoid violation of the closure.

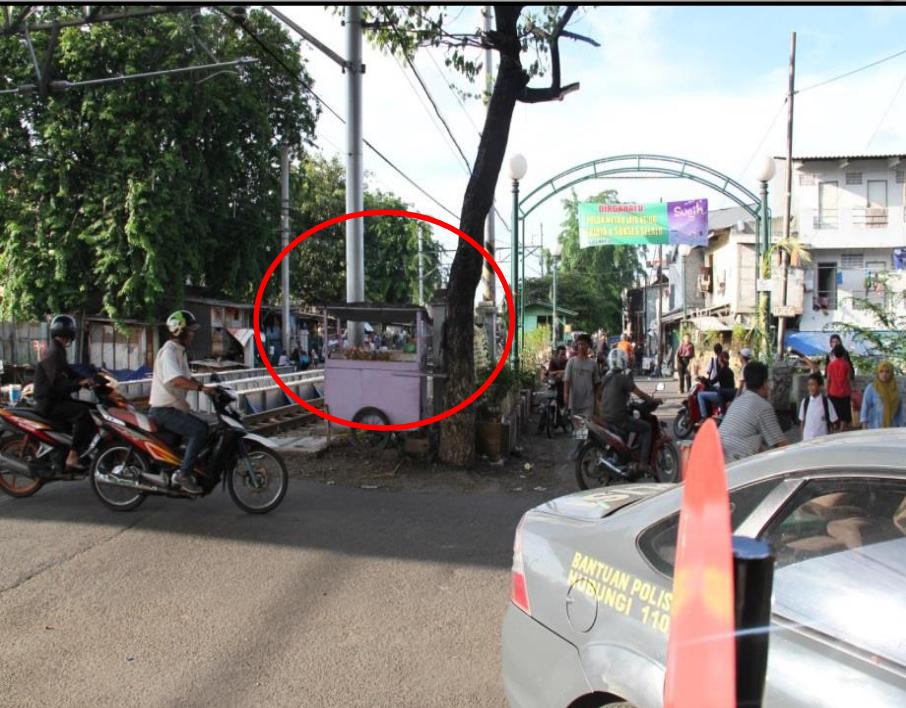
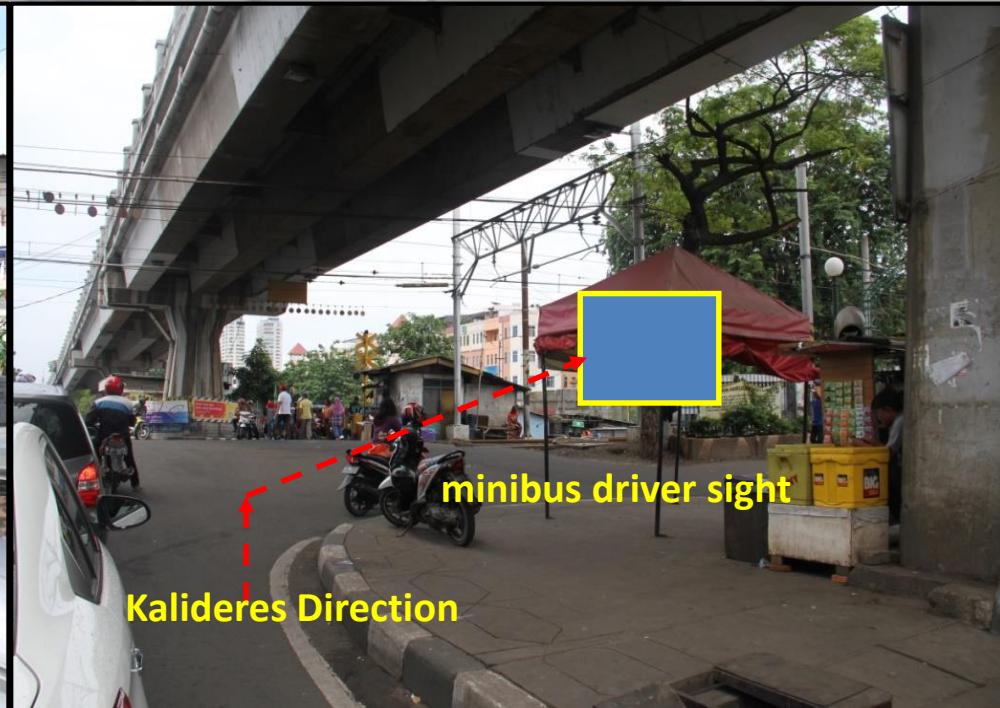
Minibus driver sight was obstructed by buildings, trees, petrol kiosk and therefore he could not see incoming train 1528 travelling from Kampung Bandan.

According to site observation, it was predicted that the minibus driver could not see the movement of incoming train 1528 from Kampung Bandan because it was covered by illegal building, trees and petroleum kiosk located in railway. This is not comply with Minister of Transportation Decree No. 36 Year 2011 on crossing between railway and other buildings Chapter 4, stating ". there is environment conditioni that enable free sight both for the machinists of the train (at least 500meters) and motorized vehiicle drivers (at least 150meters). At accident site the free sight distances were too short. The minibus drive could only recognize the arrival of train 1528.

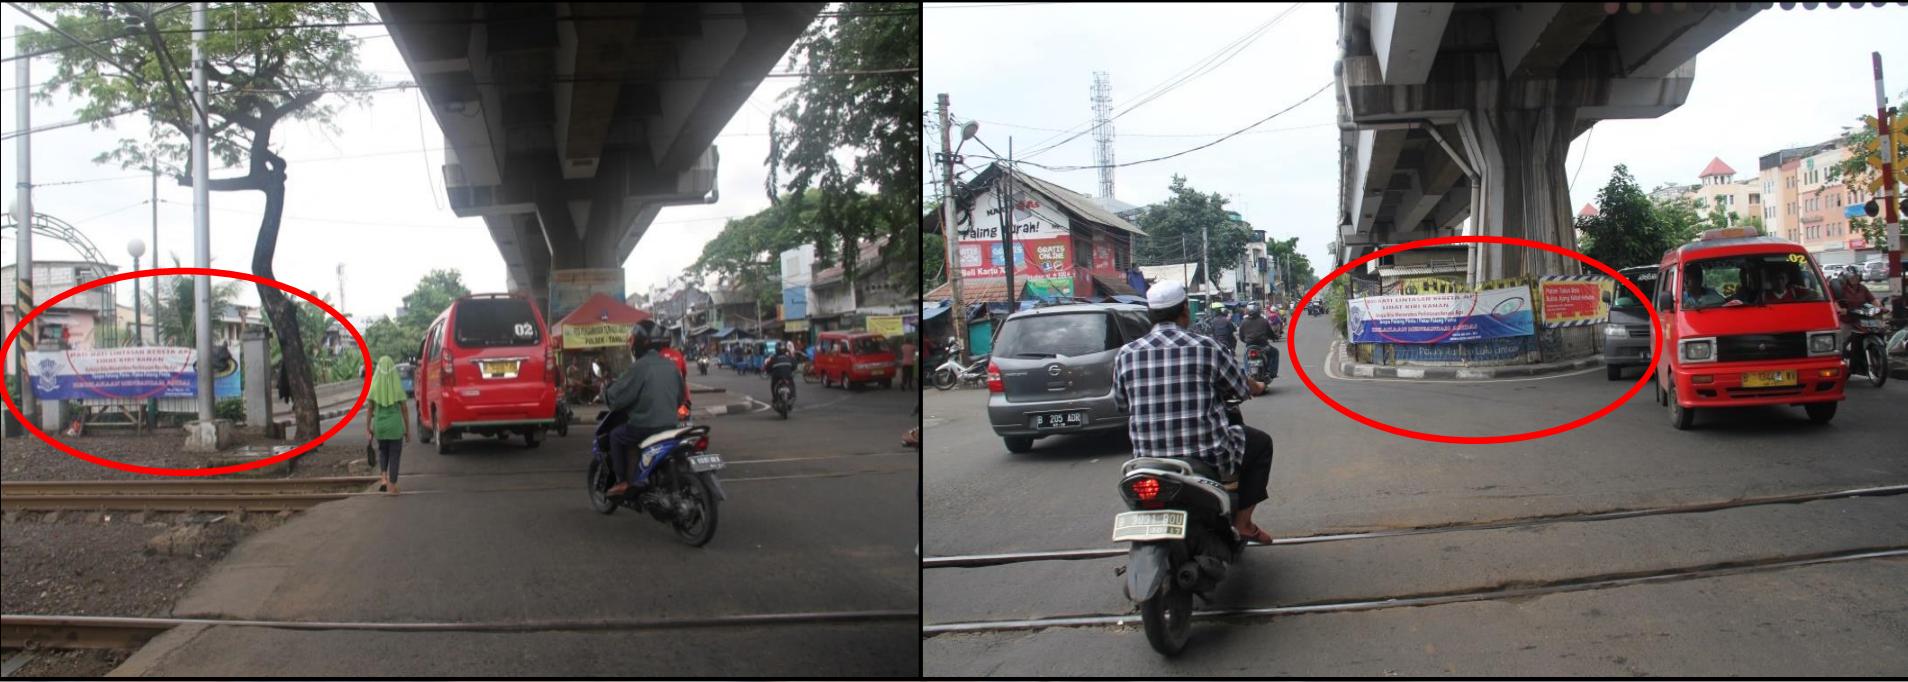
The backdrop to warn the people to be careful when crossing the railway and the danger of violating the railway crossing closure. Installed in both directions of the traffic

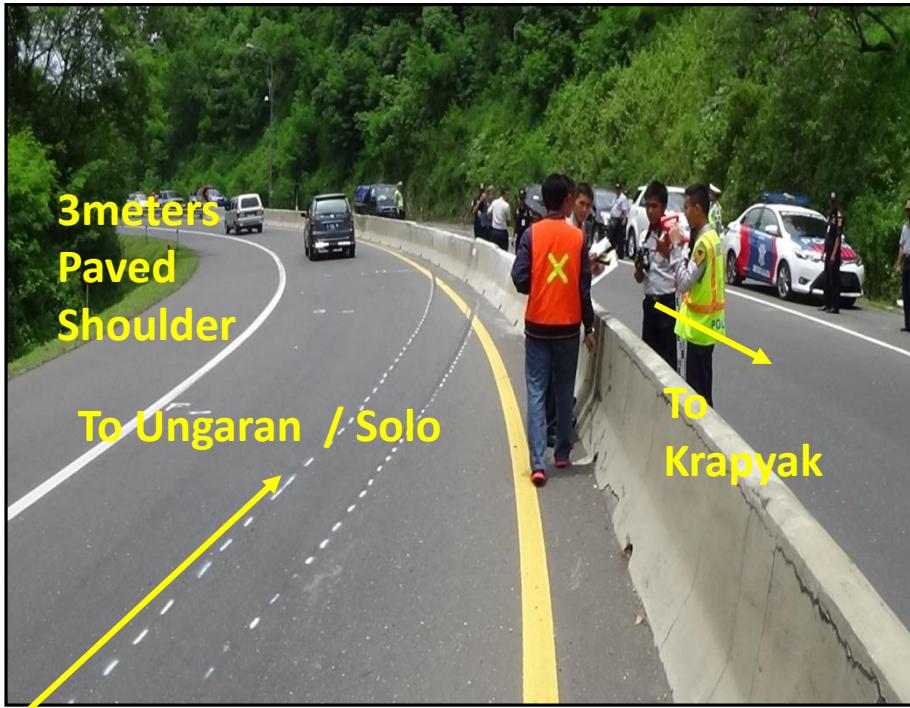
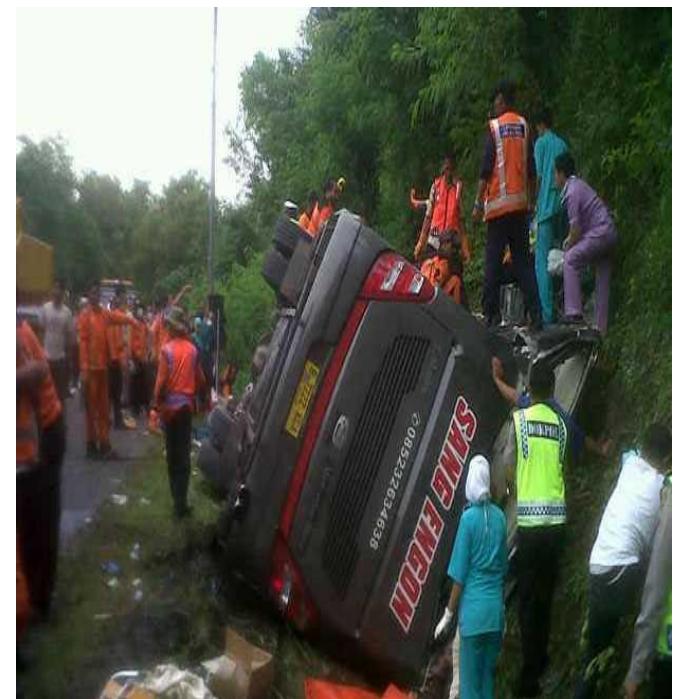
BUS B-7222-KGA ROLLED-OVER AT EXIT RAMP OF JATINGALEH KM 9+300, SEMARANG TOLL ROAD, CENTRAL JAVA, FRIDAY, 20 FEBRUARY 2015 ,1.00 P.M.

- Driver fatigue due to excessive driving hours (more than 10 hours)
- Driving 90 kph exceed speed limit (40 kph) for exit ramp with sharp curve.
- The sharp curve was not accompanied with appropriate superelevation to overcame centrifugal force. The situation was getting worse due to asphalt overlay process without considering appropriate superelevation.
- The bus carry 64 passengers, far beyond normal capacity of 45 seats.

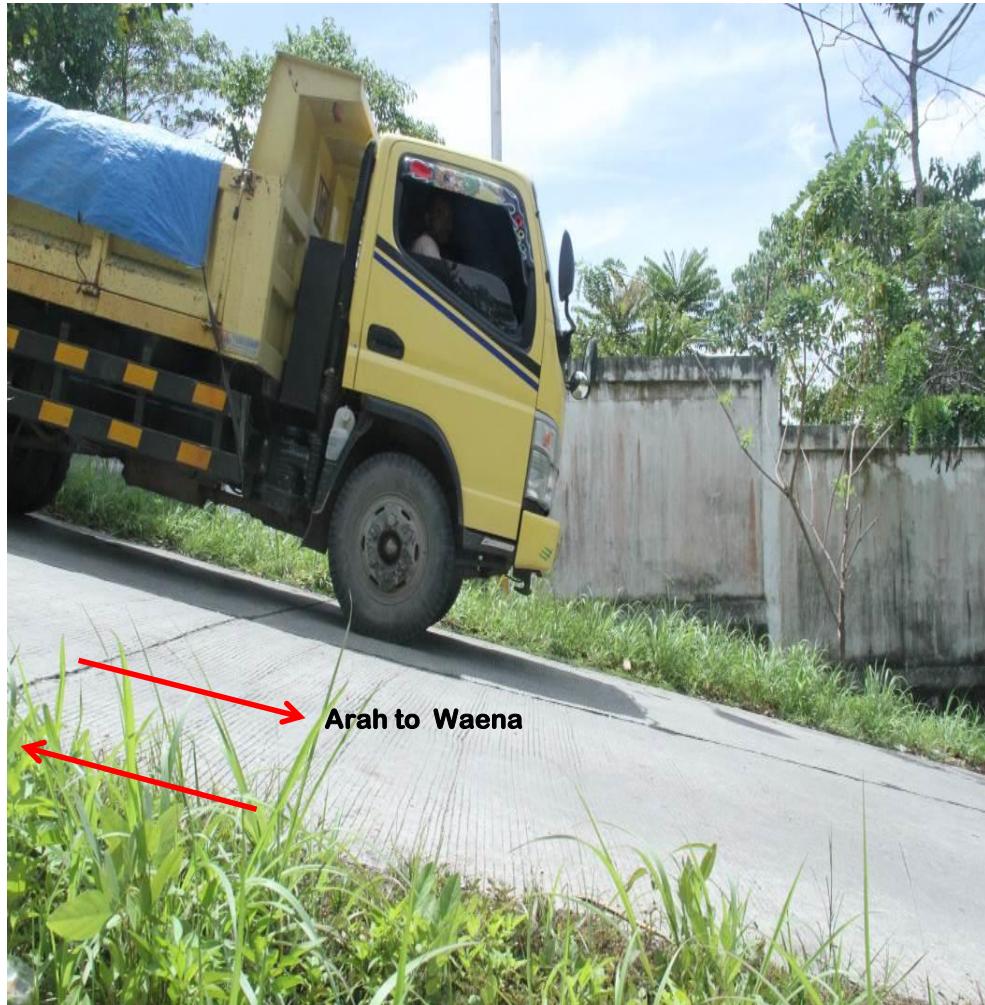
KECELAKAAN TUNGGAL MOBIL BARANG DUMP TRUK DS-9675-AB
MASUK JURANG DI JL. ALTERNATIF PERUMNAS III WAENA-
ENTROP, JAYAPURA , MINGGU 11 JANUARI 2015 PUKUL 13.00 WIT

- Sunday, 11 January 2015, 11.00 a.m. (Eastern Indonesian Time) a Dump Truck DS-9675-AB departed from Argapura, Jayapura, carrying 51 passengers including driver heading to tourism site at Kampwolker.
- At about 1.00 p.m. the truck was almost reaching the destination. The road gradient was extrem downhill (more than 10%).
- The driver could not control the truck and end up rolled over in the dry Kampwolker river.
- 9 passengers died and the other 42 were injured.

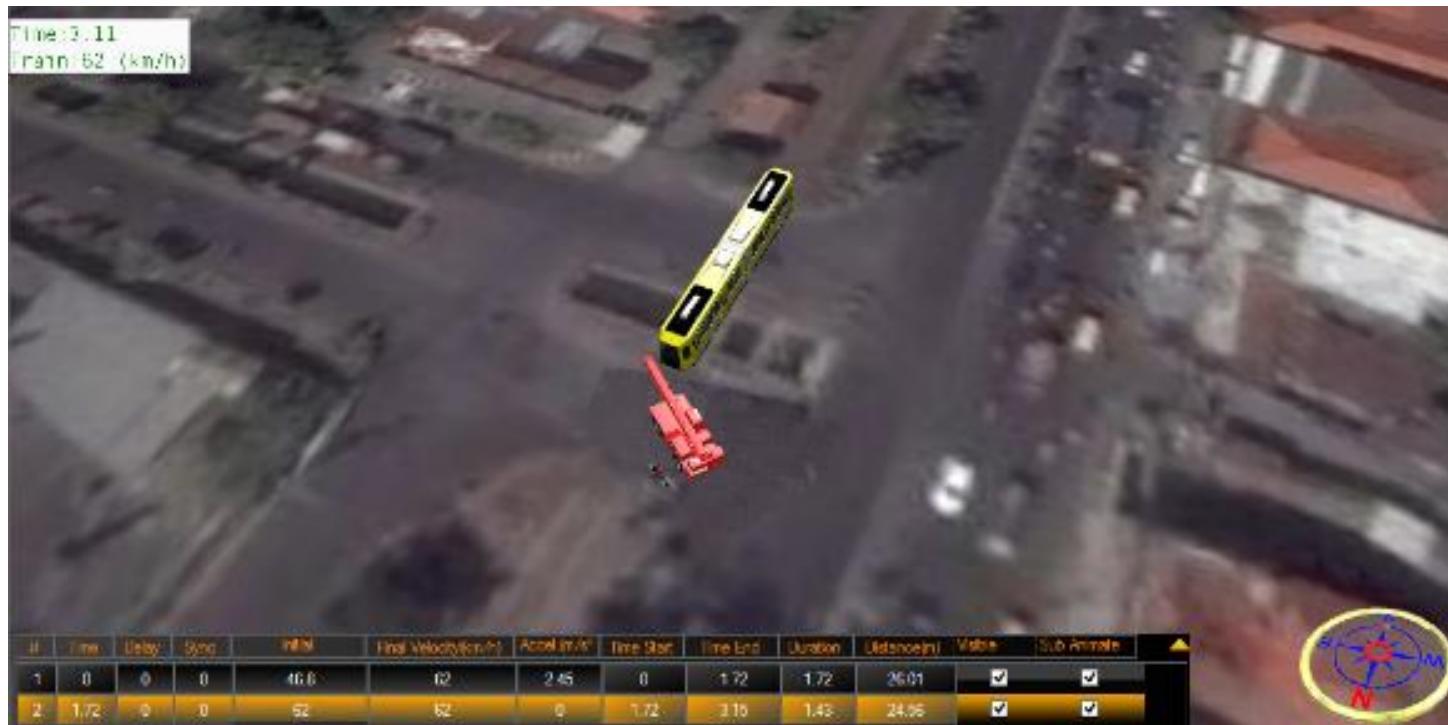
The Crash

- Mobile crane was operated in public road. According to the legislation, it should be carried by a truck. On the at grade railway crossing, the crane the crane could not stop before the stop sign. As a result when the train cross the accident site the boom of the crane had already reach above the railway.
- Information regarding the schedule of special train was only received by the head of stations along the route of the special train. This was not forwarded to the doorstop attendant. This was just because the attendant in the accident site was employee of Sidoarjo Regency Transport Agency and was not the employee of the Indonesian Railway Company.

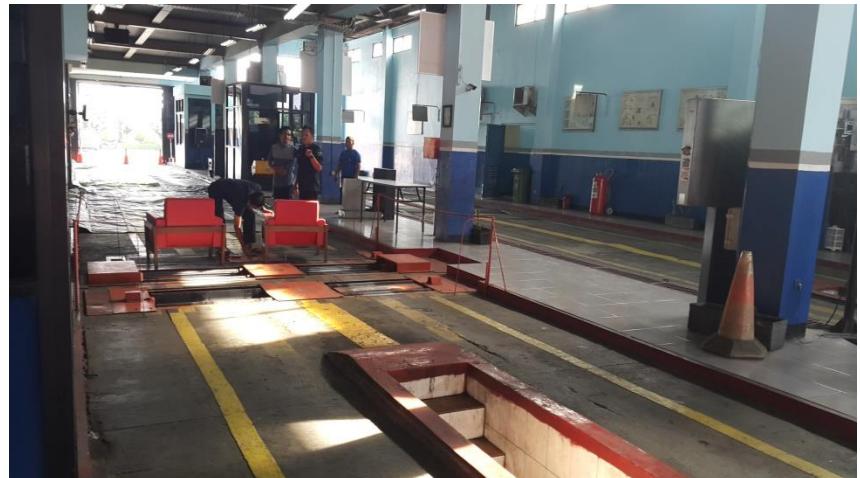
Type approval for new vehicle type in Indonesia, include only test of some vehicle parts and analysis of drawing and specification. No physical test such as crash test is conducted. Therefore due to accident, it was often that vehicle superstructure seriously deformed. Corrosion made the deformation more serious. Mandatory periodic vehicle inspection is conducted every 6 months. But this is far from comprehensive. Moreover number of routine vehicle inspection unit are limited. Indonesia has limited resources both financially and in terms of man power.

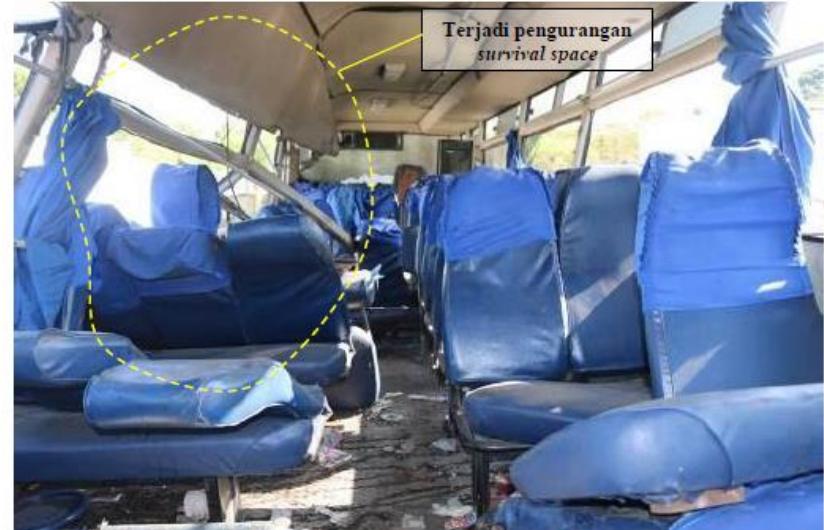
Excessive deformation on vehicle cause on reduction of survival space for passengers and driver. This condition could cause more fatalities and more severity of the injured persons. Therefore for future new vehicle type approval, physical test should be conducted including superstructure.

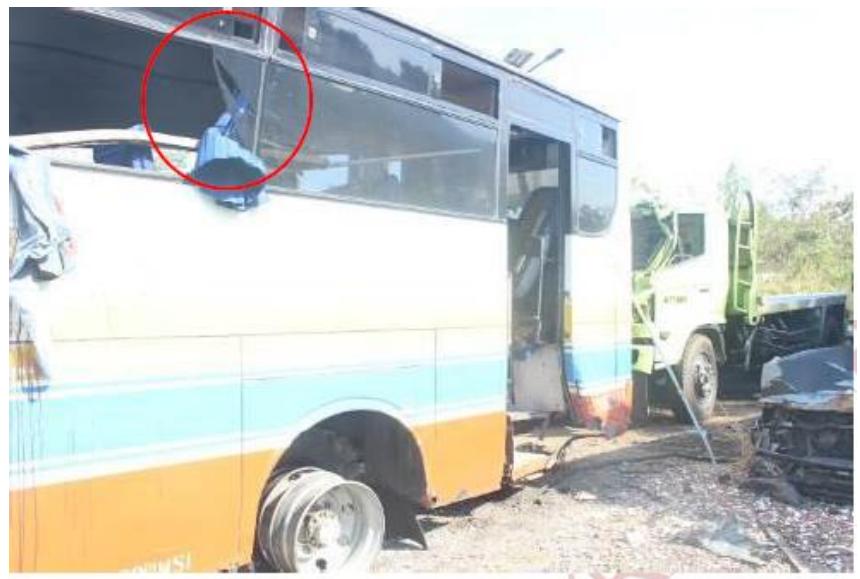
Some vehicles still use non-safety glass, causing sharp pieces of window which endanger the passengers and the driver after crash.

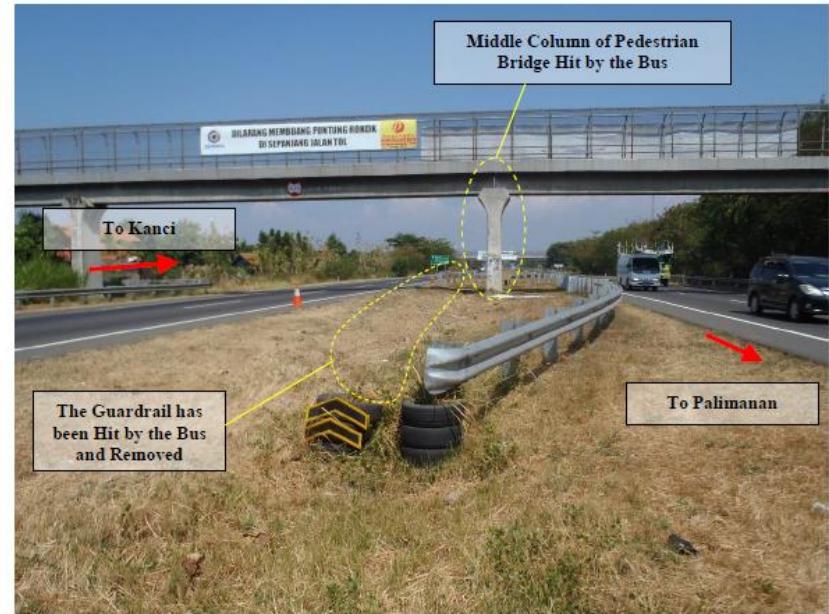
Straight and level highway with high speed vehicles are dangerous. In such highway often found middle column for pedestrian bridge or vehicle overpass . For freeway it is recommended not to use middle column and use prestress beam to get longer span or cable stayed support
