Application Of Quality Control Of Carton Box In Quality Control Department At PT Purinusa Ekapersada

Clara Puspita Ningrum[1*], Lina Gozali[1], Lamto Widodo[1]

[1] Industrial Engineering Department, Faculty of Engineering
Universitas Tarumanagara
*clara.545160068@stu.untar.ac.id, ligoz@ymail.com, lamtow@yahoo.com

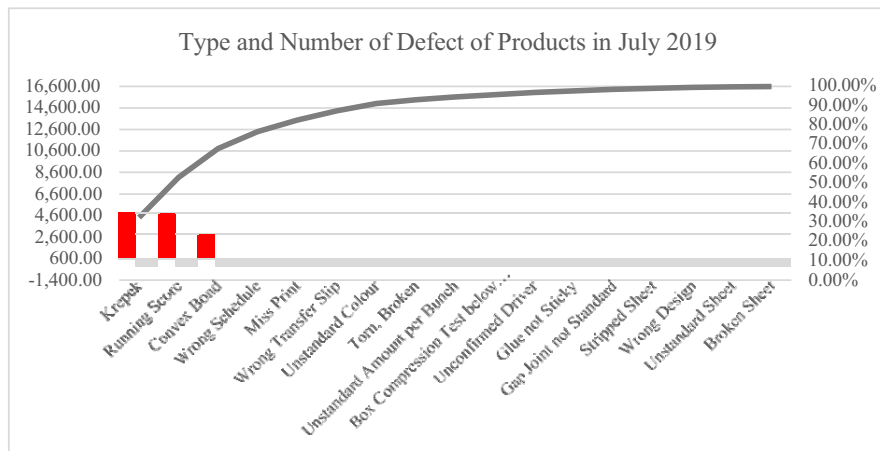
Figure 1. Pareto diagram of defect of products in July 2019

In July 2019, PT Purinusa Ekapersada produced 2.758.491,15 kg of carton box. The data of the type and number of defect of carton box produced in July 2019 and the pareto diagram can be seen in Table 1 and Figure 2.

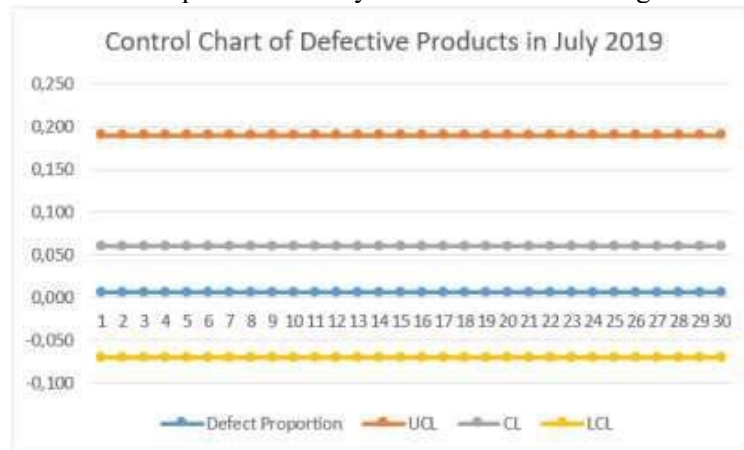
Figure 2. Control chart of the defective products in July 2019

Control chart of the defective products in July 2019 can be seen in Figure 2.

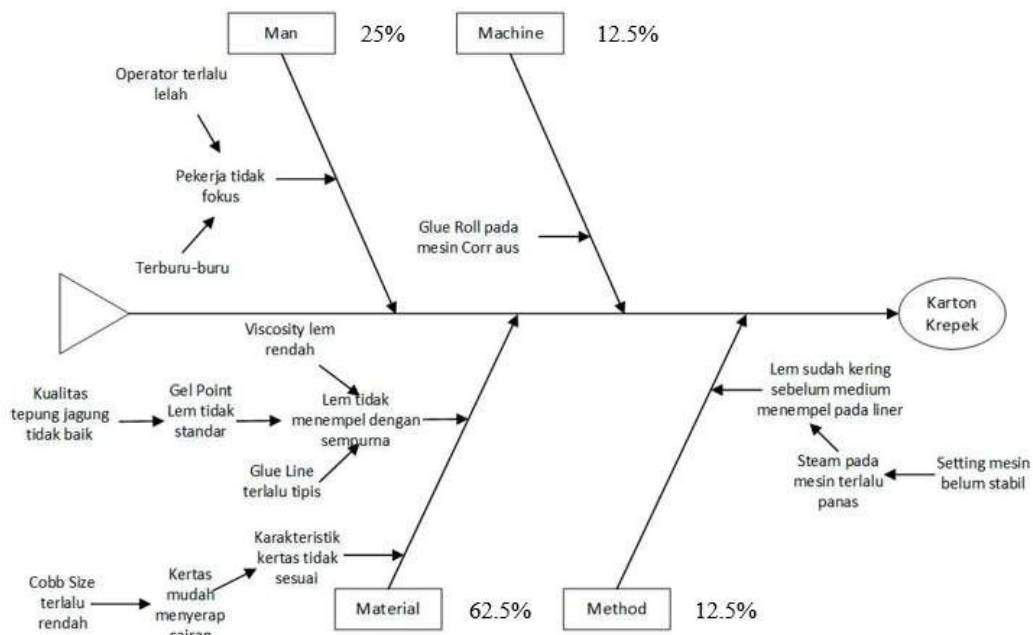
Figure 3. Fishbone diagram of "krepek" defect

3.3. Fishbone diagram
Of all types of defects found in carton box produced at PT Purinusa Ekapersada, the type of "krepek" and "score lari" are the most common types of defects that occurred in July 2019, as many as 32.34% and 20.64% of the total number of defects found . The fishbone diagram of the "krepek" defect can be seen in Figure 3 [4].

Based on the fishbone diagram of the "krepek" type defects above, it can be seen the causes of defects in the defective products. The cause of the defect itself is divided into several categories, namely 4M (Man, Material, Machine, Method,) and Environment. Why Analysis table of the types of "krepek" defects in the carton box production process at PT Purinusa Ekapersada can be seen in Table 3.

Analysis	Root Cause(s)	Action
Man	Operator didn't focus during the production process	Safety talk is given in every shift change
Material	The characteristics of the paper didn't match and each layer didn't stick properly	Conduct material inspection, namely paper, corn flour, glue and sheets produced
Machine	The Glue Roll on the Corrugator machine was worn	A skilled technician is required to carry out regular maintenance on the machines used
Method	The steam used to heat the paper on the Corrugator machine was too hot	Wait a few moments when the engine has just started so the temperature is stable
