Lesson Learnt from Road Accident Investigation in Indonesia

Prof. Ir. Leksmono Suryo Putranto, MT, Ph.D
Professor in Road Traffic Safety, Tarumanagara University
Head of Road Transport Accident Investigation
National Transport Safety Committee

International Seminar on Sustainable Transportation and Safety Measures
Smart Driving Research Center-Universiti Tun Hussein On Malaysia
Batu Pahat, 16 April 2017

**CRASH BETWEEN TRAIN 1528 FROM JATINEGARA TO BOGOR
AND MEDIUM BUS B-7760-FD FROM KAMPUNG BANDAN TO
KALIDERES AT RAIL CROSSING 05 KM 03+739 TUBAGUS
ANGKE ROAD, TAMBORA DISTRICT, WEST JAKARTA,
SUNDAY, 6 DECEMBER 2015, 08.43 A.M.**

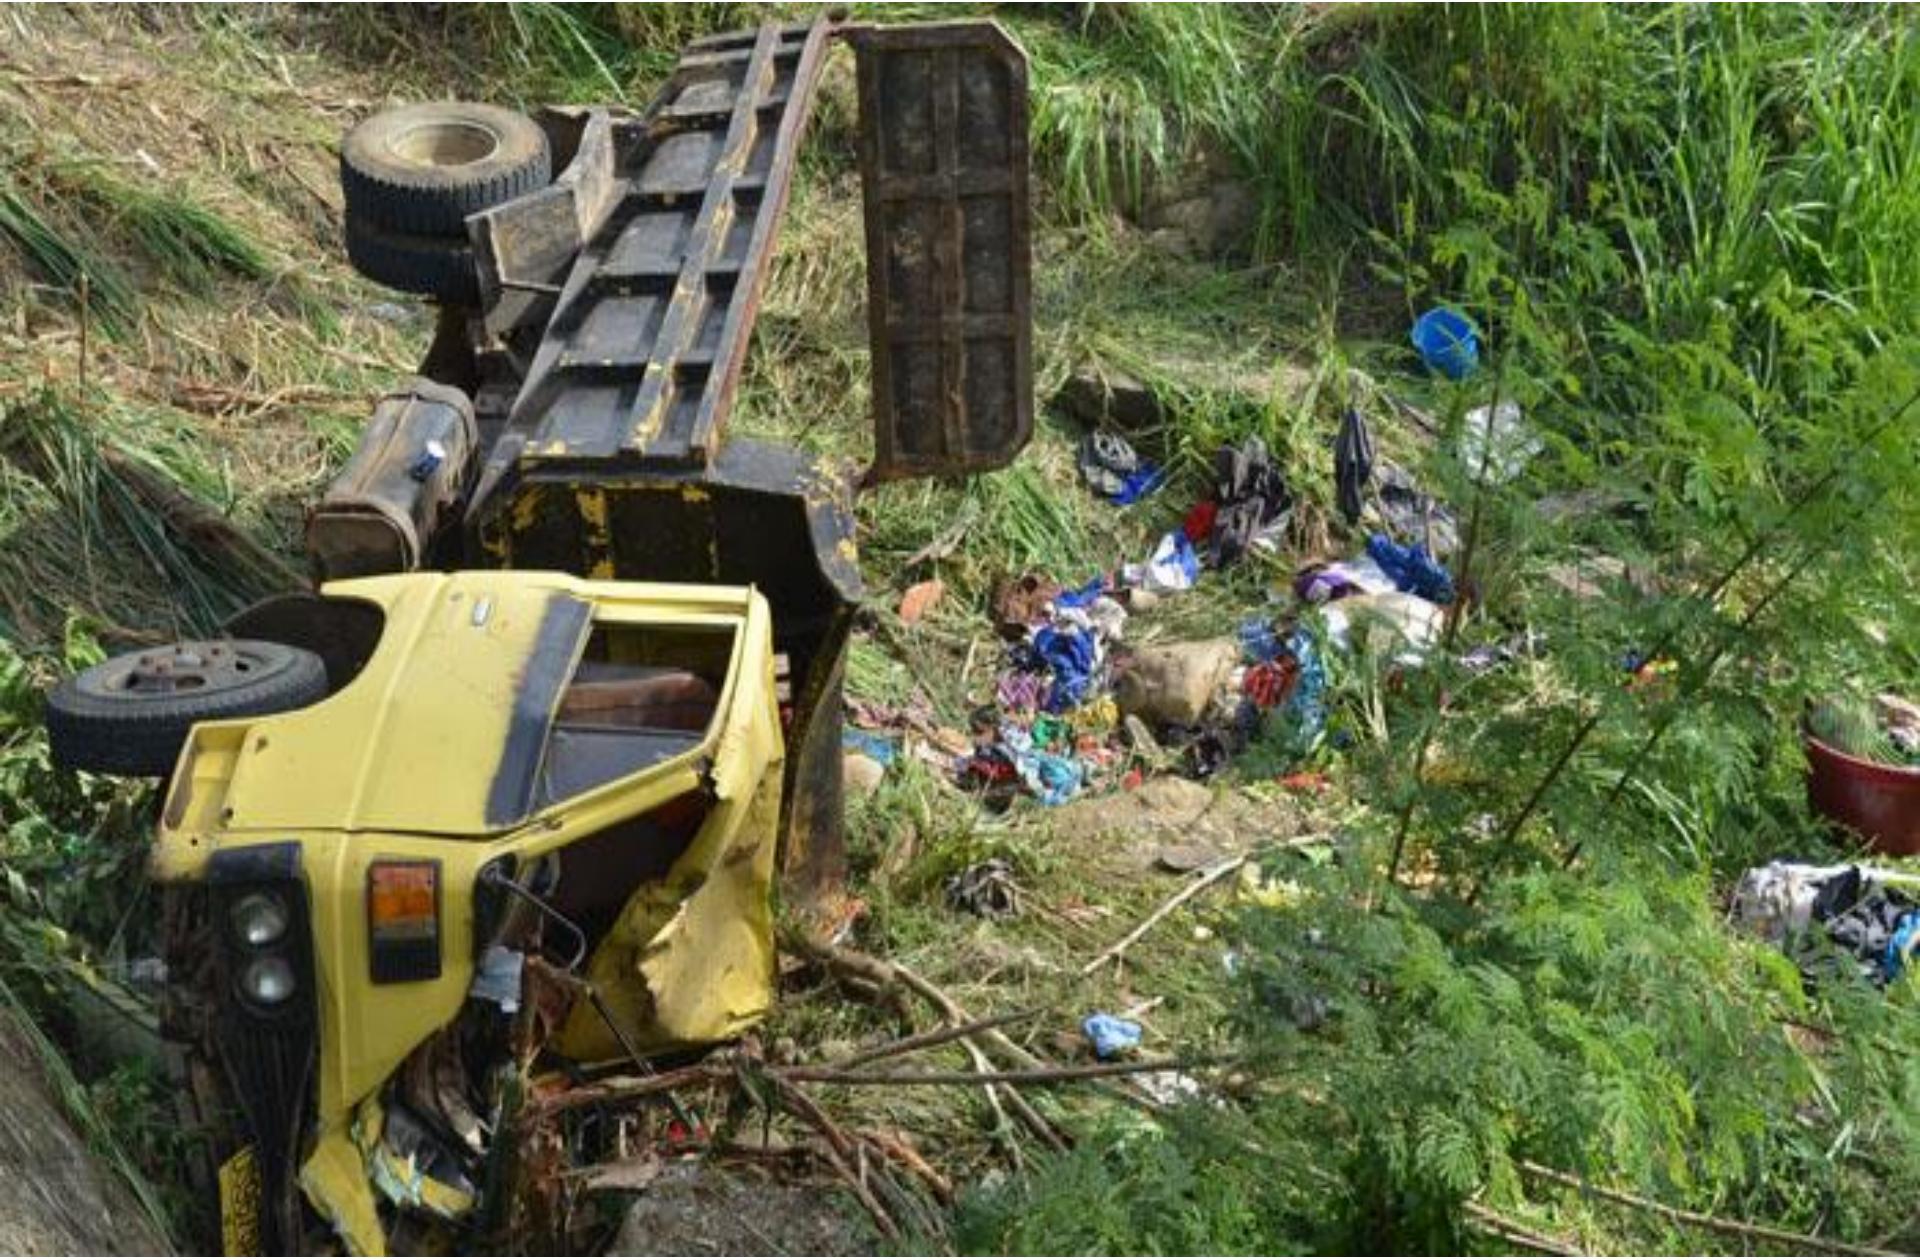
1. The vehicle is a dump truck. It was not suppose to carry passengers outside the cabin. It was not well maintained. The latest date of mandatory vehicle inspection was 30 May 2010. There was no other vehicle inspection carried out until the accident happened 11 January 2015 although the mandatory vehicle inspection should be done every 6 months.
2. The driver was not well trained to overcome complex driving situation such as extreem gradient.
3. The road gradient was extreem (beyond 10%).
4. Guard rails were not installed in the roadsides, although some of the roadsides were deep cliffs.

5. There was some water in the hose of brake fluid. This was affecting the braking system performance.
6. The depth of the tire groove of the left side tires were below requirement.
7. There was no stopper on the rear shockbreaker which was affecting vehicle stability.
